## **PIPELINE PERFORMANCE EXPERIENCES DURING SEISMIC EVENTS IN NEW ZEALAND OVER THE LAST 27 YEARS**

**Frank W. O'Callaghan**, Iplex Pipelines NZ Ltd, New Zealand

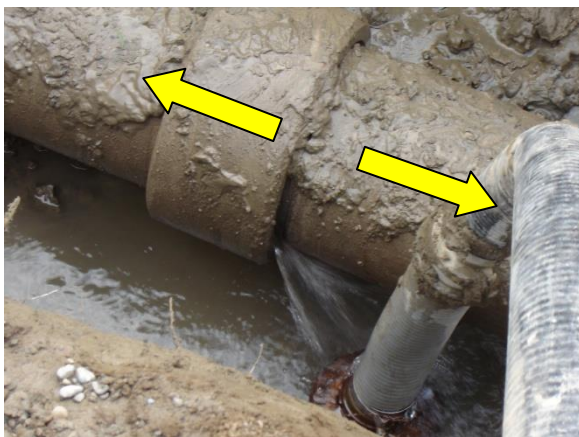
Figure III - Tension effects in AC pipe joint, Sewell Street Kaiapoi, axially aligned with the Darfield/Christchurch epicenter

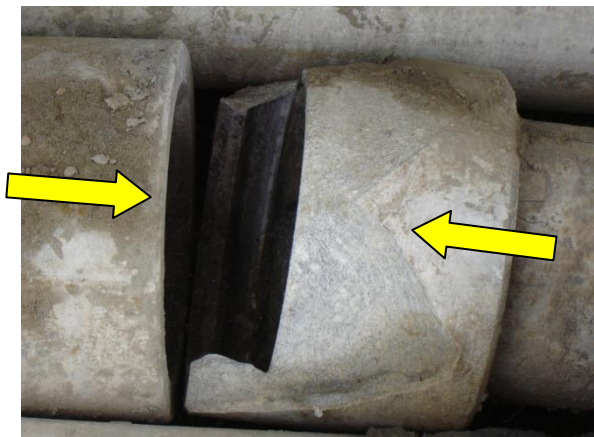
Figure IV - Compression effects in AC pipe joint, Sewell Street Kaiapoi, axially aligned with the Darfield/Christchurch epicenter

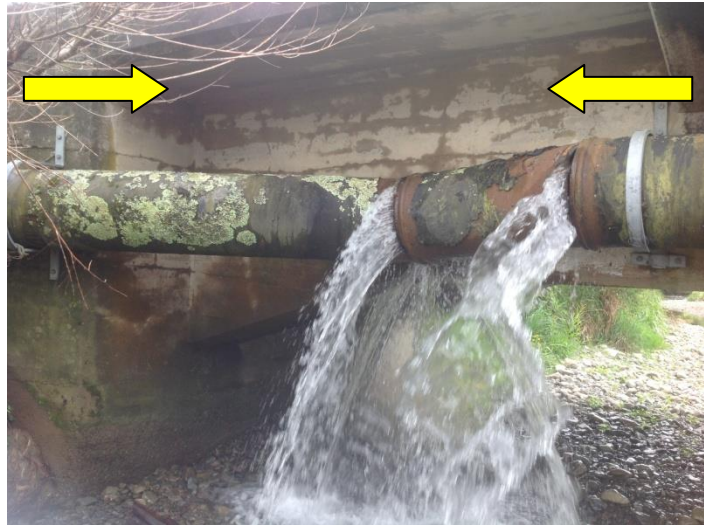
Figure V - Compression distortion and separation of gasketed joints in CLS watermain, axially aligned with the Eketahuna epicenter

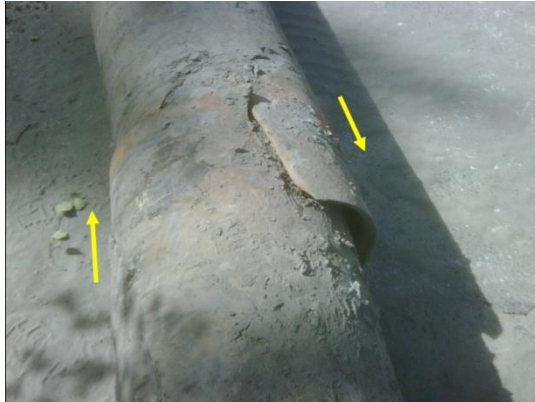
Figure VI - Compressed joint movement In CLS water main, Christchurch

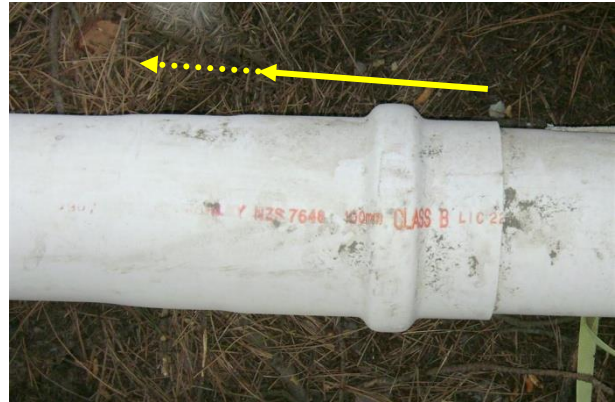
Figure VII – Compressed ductile joint movement in PVC-u water main, Christchurch

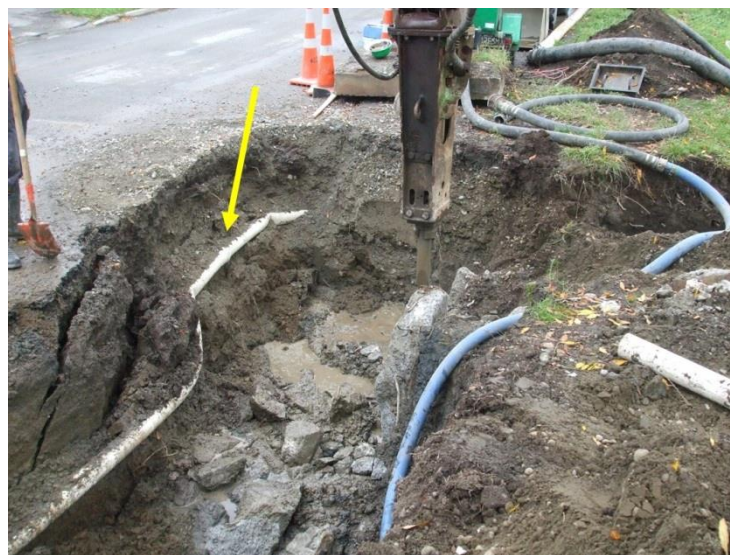
Pipe material behaved in surprising ways. In Christchurch, DN 100 (4 inch) PVC-M pressure pipe, manufactured in 1996 was pushed sideways by sudden lateral spread and squashed behind a large concrete sewer chamber in the Avon river bank. (Figure VIII). The pipe was found to be still under pressure with reduced flow. The bell and spigot rubber ring joint in the middle of the displaced pipe section which had “pulled” longitudinally about 15 mm, but had permitted the expansive movement, undamaged.

Figure VIII - Distorted but still operational, DN100 PVC-M water pipe with joint, Christchurch

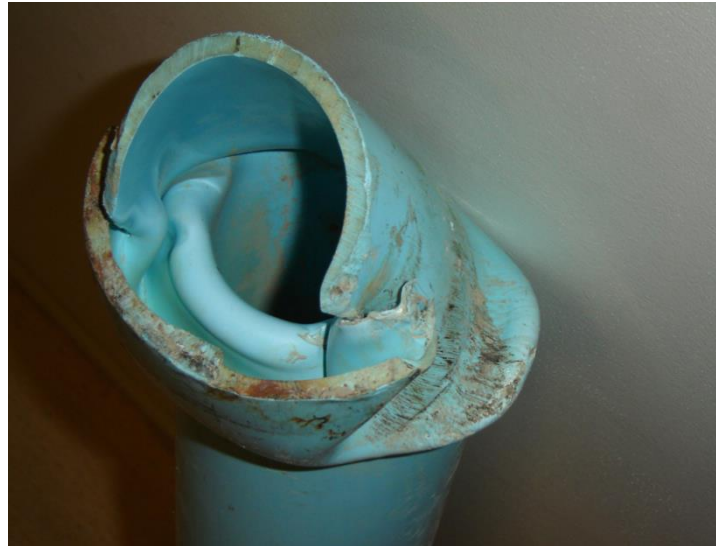
At the Gayhurst Road overbridge crossing the Avon River in Christchurch, lateral spread rapidly drove PVC watermain axially into the bridge abutment, to cause ductile axial buckling (Figure IX), and disintegrated the CI pipe and joints in the bridge. The crossing connections were quickly repaired with PVC pipe and mechanical couplers, requiring low operator skill no electricity to install, and no road access to the site.

Figure IX - Ductile axial compression folding in PVC pipe, Gayhurst Road over bridge
